## **Post-fire assessment and reinstatement of steel structures**

C. Maraveas<sup>1,2,\*</sup>, Z. Fasoulakis<sup>2</sup>, K.D. Tsavdaridis<sup>3</sup>

### **Abstract**

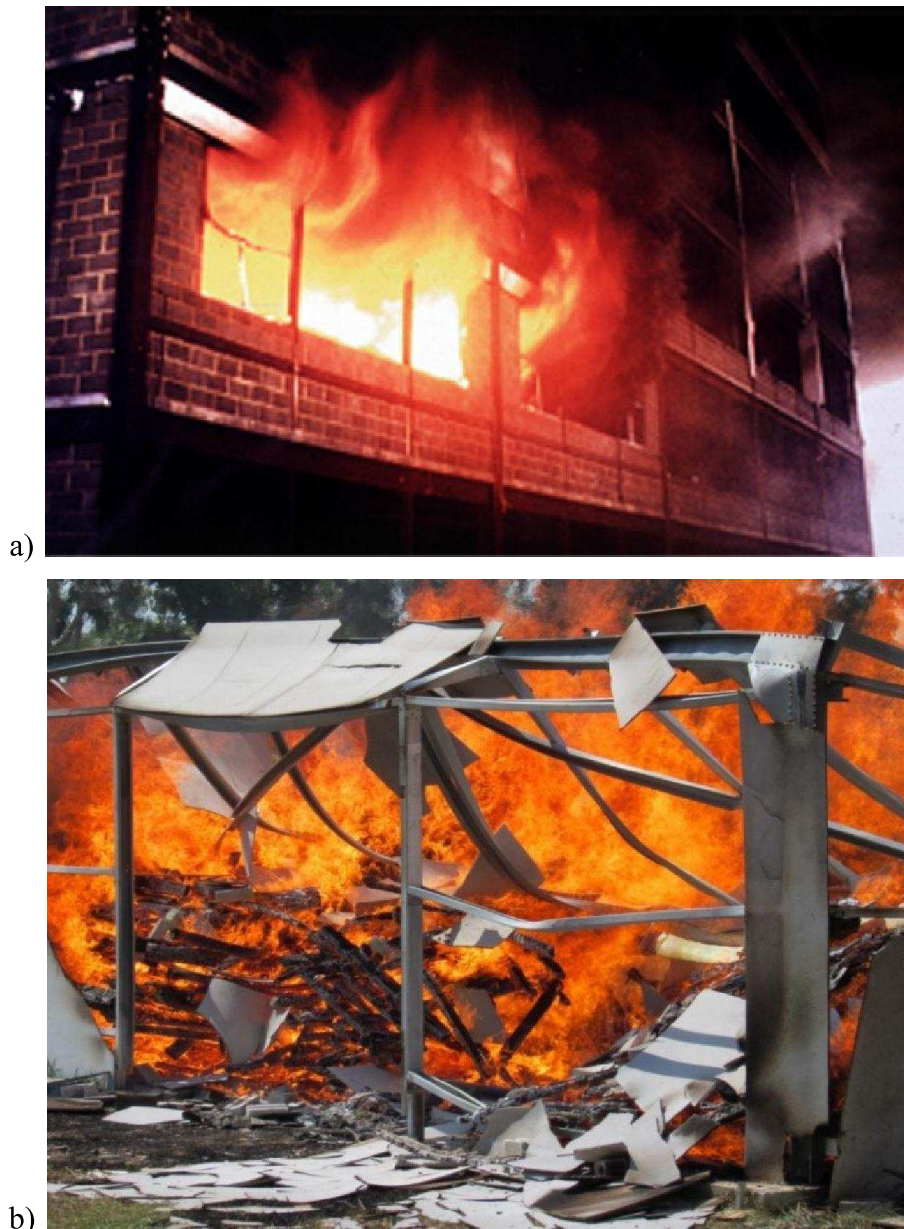
**Figure 1.** Fire tests in progress, conducted by a) Kirby et al. [21] and b) Johnston et al. [22].

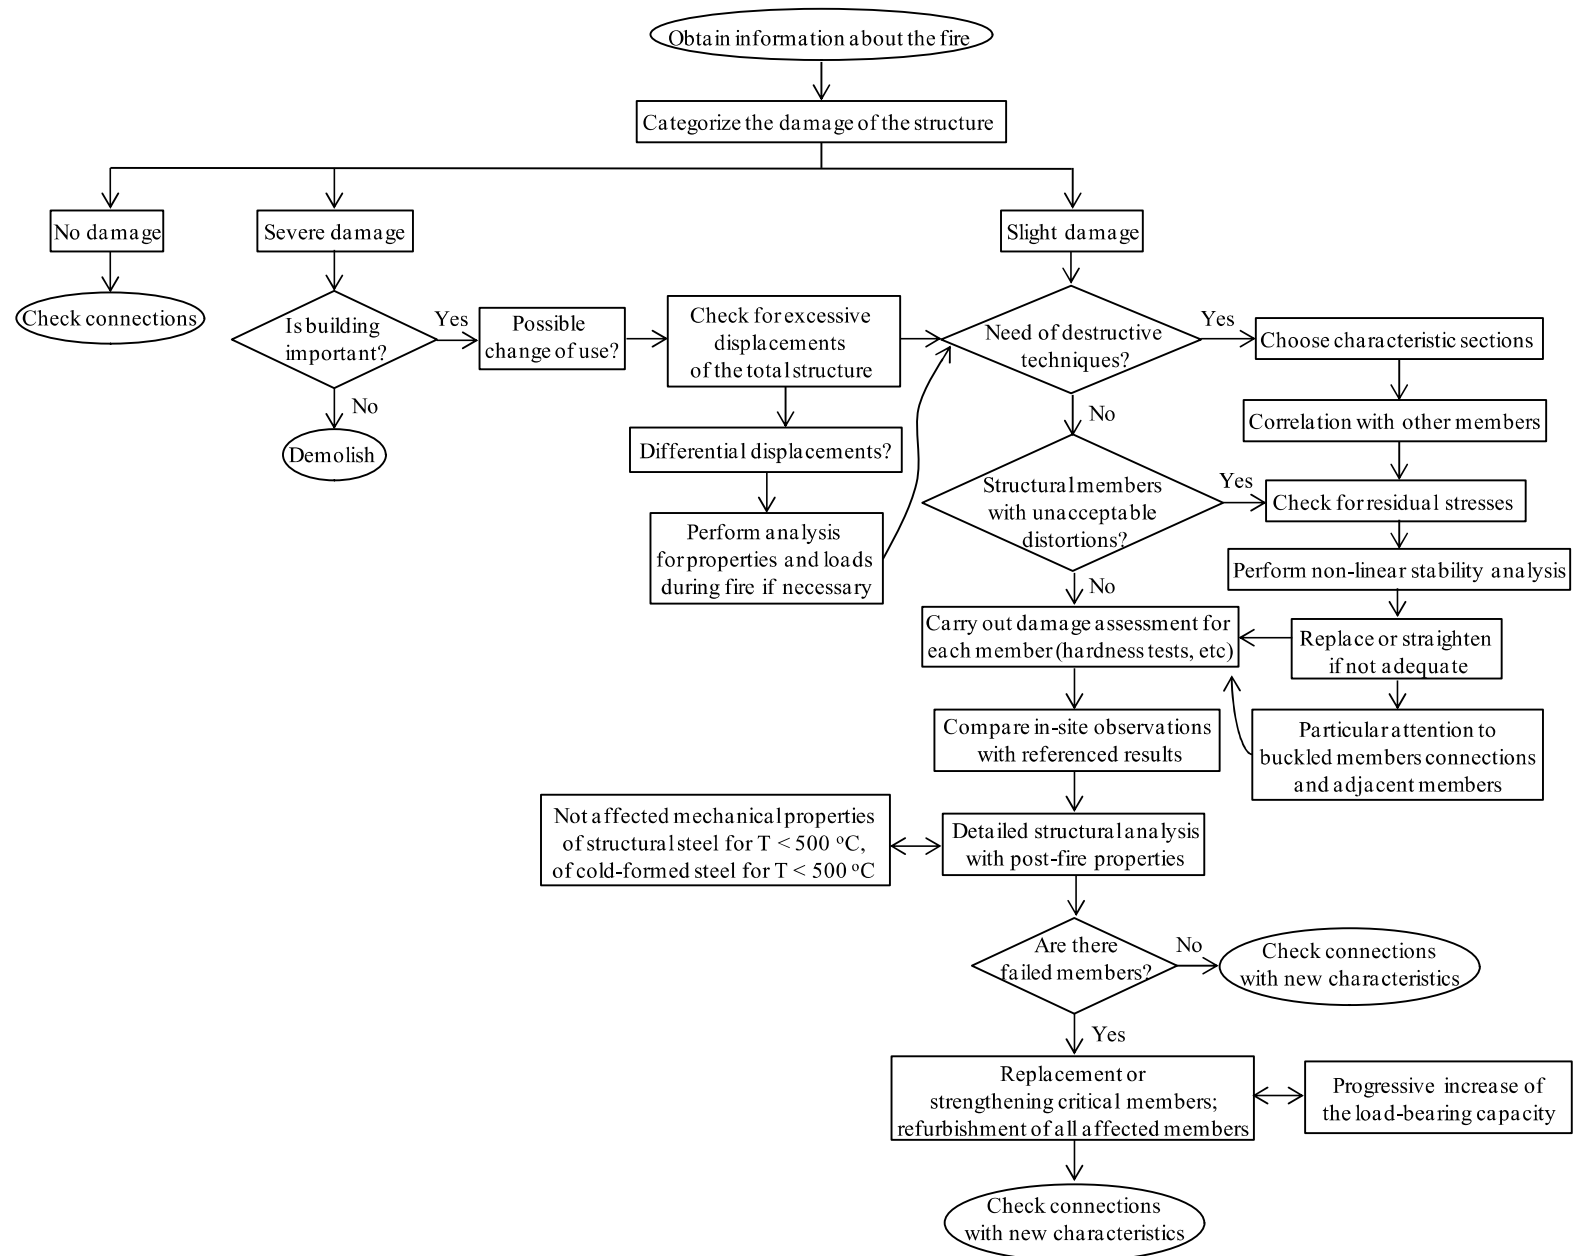
**Figure 2.** Reinstatement survey flow chart for fire damaged steel structures.

The step-by-step process of the fire damage appraisal is dissimilar to the fire resistant design of structures, which can be followed by prescriptive approaches. **Fig. 2** depicts the reinstatement survey flow chart of steel structures which illustrates the basic steps.

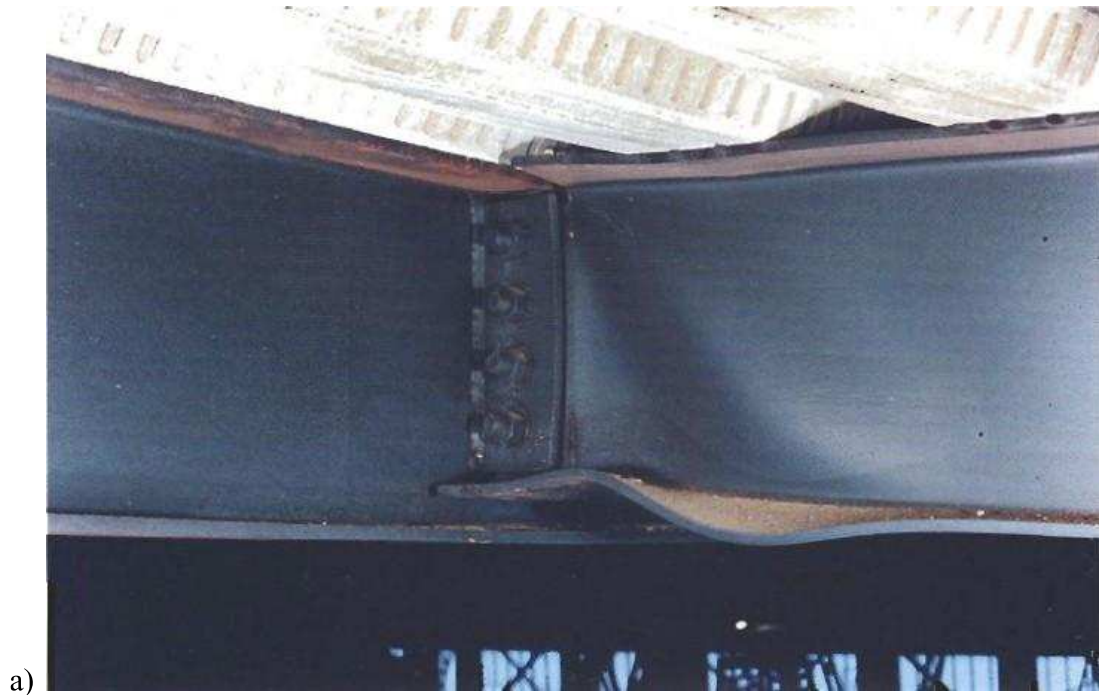
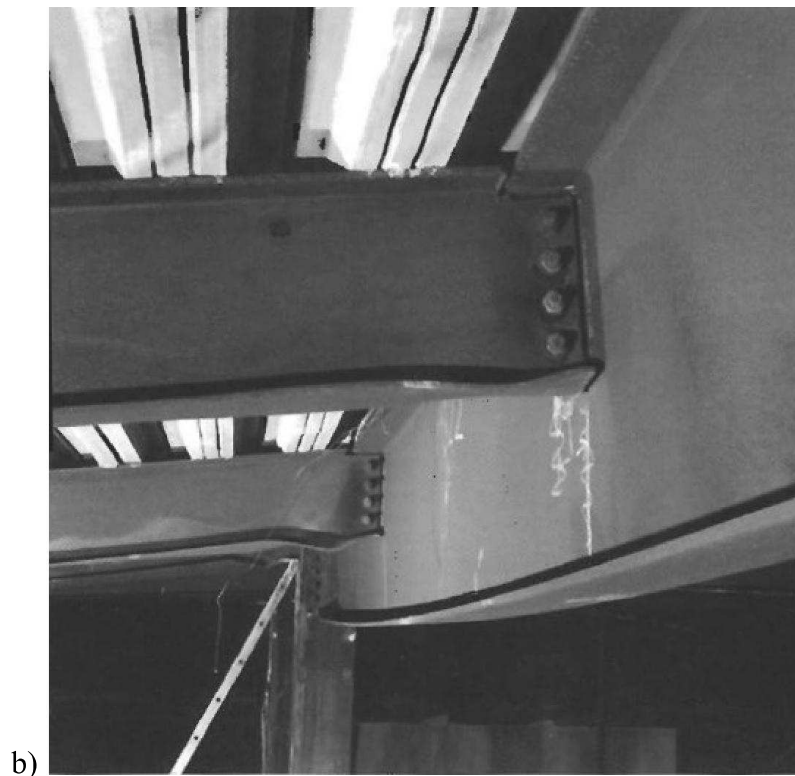
**Figure 3.** Fin-plate connections of secondary beams showing local buckling [21].

The observation of fire damaged elements provides to the engineers great insight into the ability of structures to withstand in the fire. For this reason, structural deformations of special interest, created during or after fire events are attached in **Figs. 3-4**. In particular, local buckling of the bottom flange and web folding occurred at a secondary beam (**Fig. 3a**) during the heating and cooling phases of the Cardington multi-storey steel frame test, respectively [21]. Such failure is attributed to the axial rigidity of the adjacent connection, the bolts of which do not seem to be affected. In this case, it is highly recommended for the inspector to check for any possible twisting of the primary beam, as it is observed for the corresponding one in **Fig. 3b**. Another failure that highlights the stress development during the cooling phase is attributed to the shear fracture of the bolts at the fin-plate joints. These facts reinforce the statement that localized damages of key elements may be more critical for the overall stability. Another type of distortion, regarding cold-formed steel frames, is observed in **Fig. 4** [12]. The column under investigation is regarded

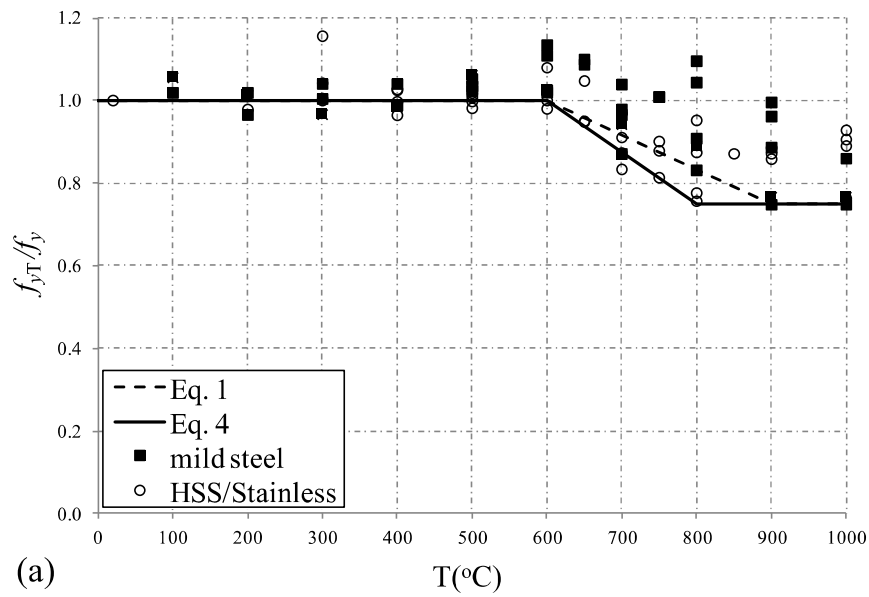
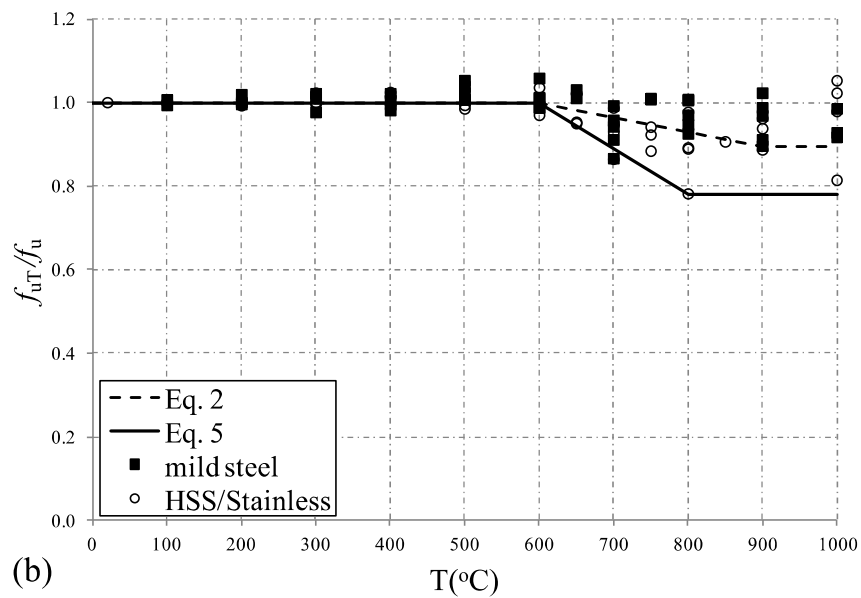
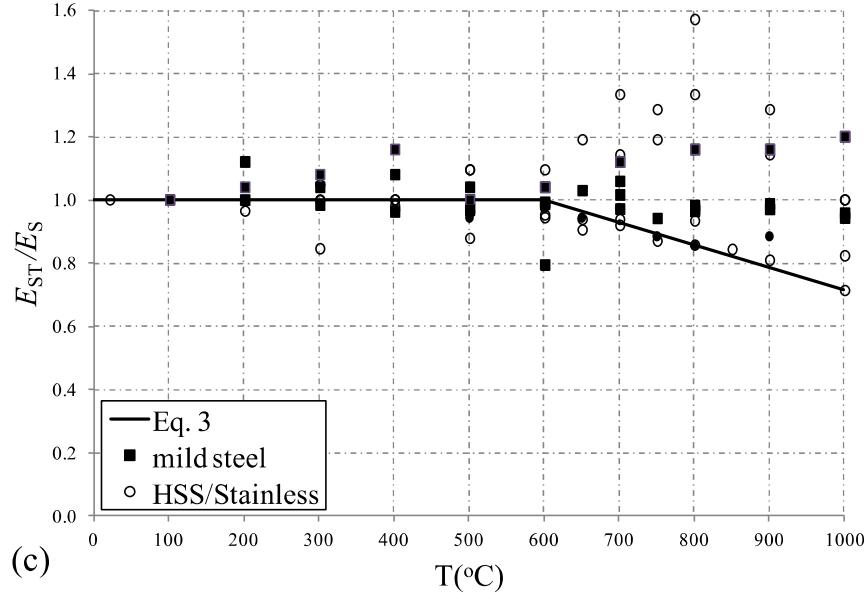
**Figure 6.** The ratio of a)  $f_{yT}/f_y$ , b)  $f_{uT}/f_u$  and c)  $E_{sT}/E_s$  as a function of temperature for hot-rolled steel.

The experimental ratios of  $f_{yT}/f_y$ ,  $f_{uT}/f_u$  and  $E_{sT}/E_s$  for hot-rolled steel are plotted in **Fig. 6**, where  $f_y$ ,  $f_u$  and  $E_s$  are the reference yield strength, ultimate strength and elastic modulus (i.e. before the fire exposure), while those with the subscript  $T$  are the corresponding temperature dependent values.

Eqs. (1)-(5) define the potential predictions and are compared with the test data. Eqs. (1)-(2) are the most accurate ones according to all test data with mild steel, but sometimes overestimate the strength of high strength steel. Eqs. (4)-(5) are recommended for practical use to determine the residual yield and ultimate strength of high strength, alloy and stainless steel after cooling down from fire temperatures up to 1000°C.

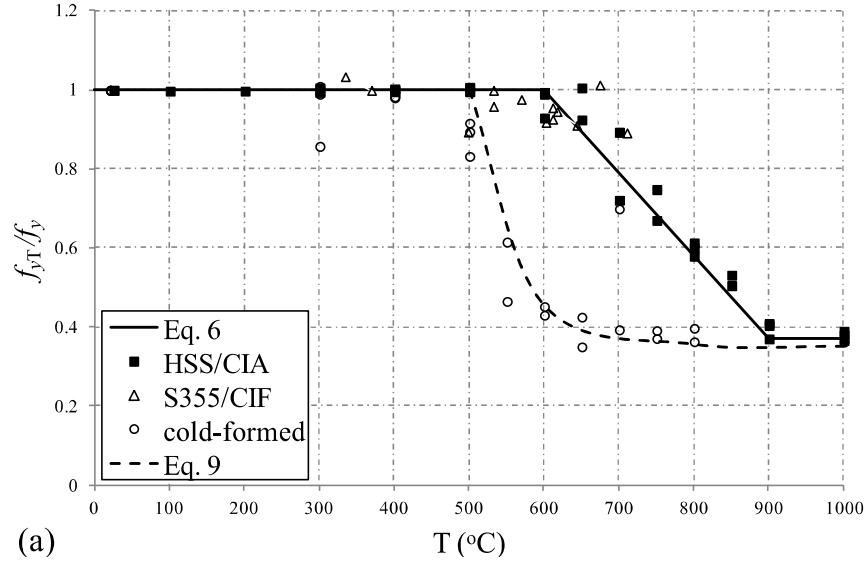
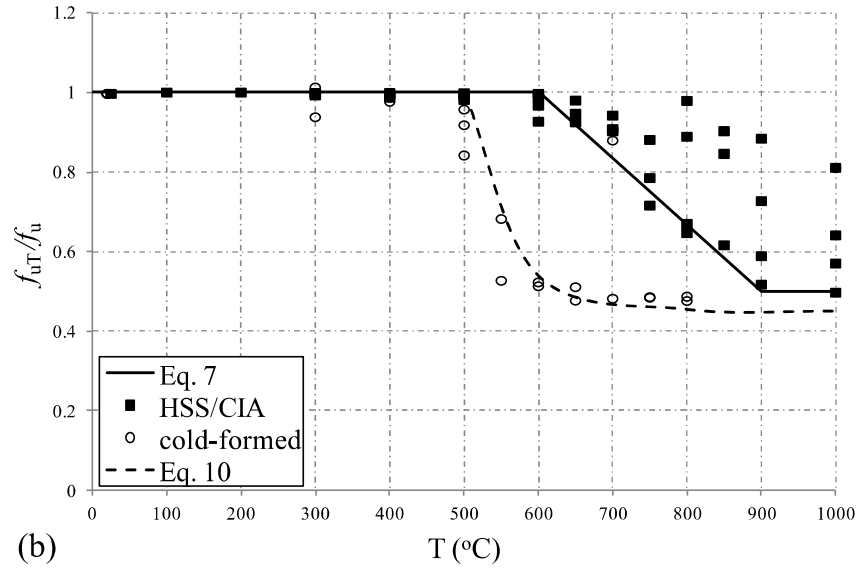
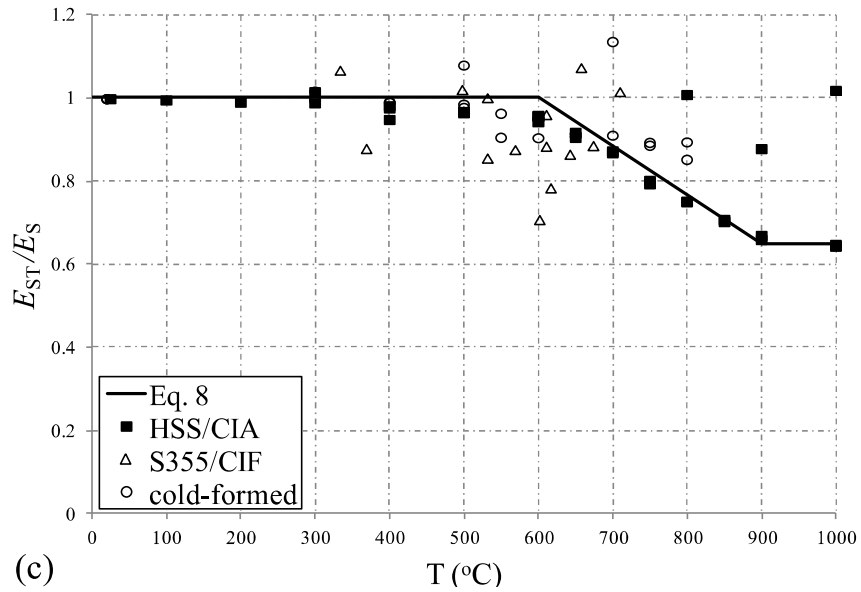
**Figure 7.** Comparison of predicted residual factors a)  $f_{yT}/f_y$ , b)  $f_{uT}/f_u$  and c)  $E_{sT}/E_s$  for heat-treated and cold-formed steel.

Post-fire mechanical properties for heat-treated steel are defined by Eqs. (6)-(8). An obvious difference between cold-formed and heat-treated steel is apparent in terms of yield and ultimate strength [6,12,13]. Therefore, the residual capacities for cold-worked steel and the sudden decrease of which is clearly illustrated in **Fig. 7**, are established by Eqs. (9)-(10), respectively. The comparison of the corresponding equations with the test data is also presented.

It is concluded that the post-fire behavior of structural steel is hardly influenced after exposure to temperatures up to 500°C. In addition, the residual ultimate strength of mild steel is found greater than 90% of the initial one, whereas none of the properties of hot-rolled steel is reduced more than 25%. The distinction between mild steel and HSS is also stated in Appendix B of British Standards 5950-8 [23], which recommends the reuse of steel grade S235 and S275, following a 10% reduction in the initial strength. On the other hand, for steel grade S355, at least 75% of the strength is regained on cooling from temperatures above 600°C, which is in agreement with the experimental results [5,7,8] (**Fig. 6**). On the other hand it is worth to note that these suggestions are considered as non-conservative for heat-treated [8,9] and cold-worked steel, as the deterioration of the capacity is more significant (**Fig. 7**; residual factors over 35%).

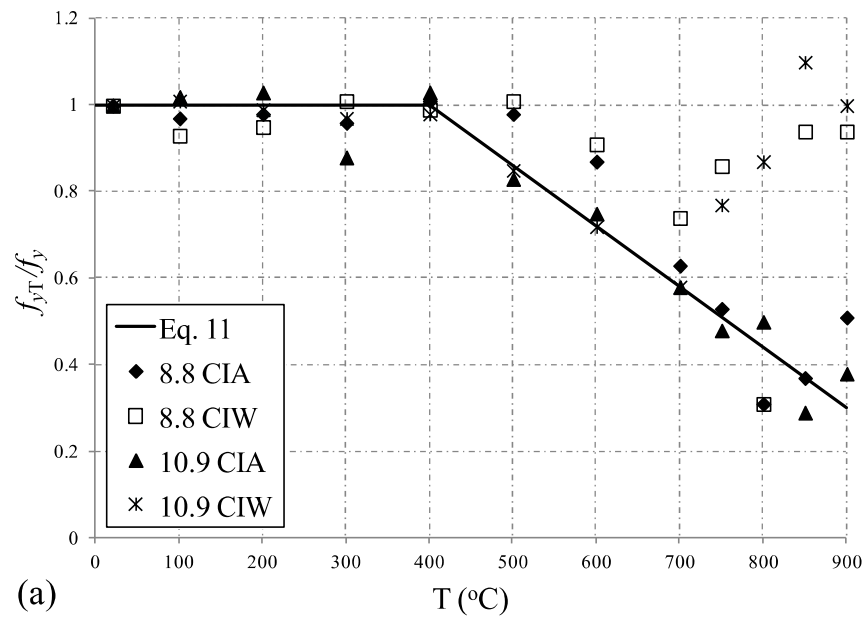
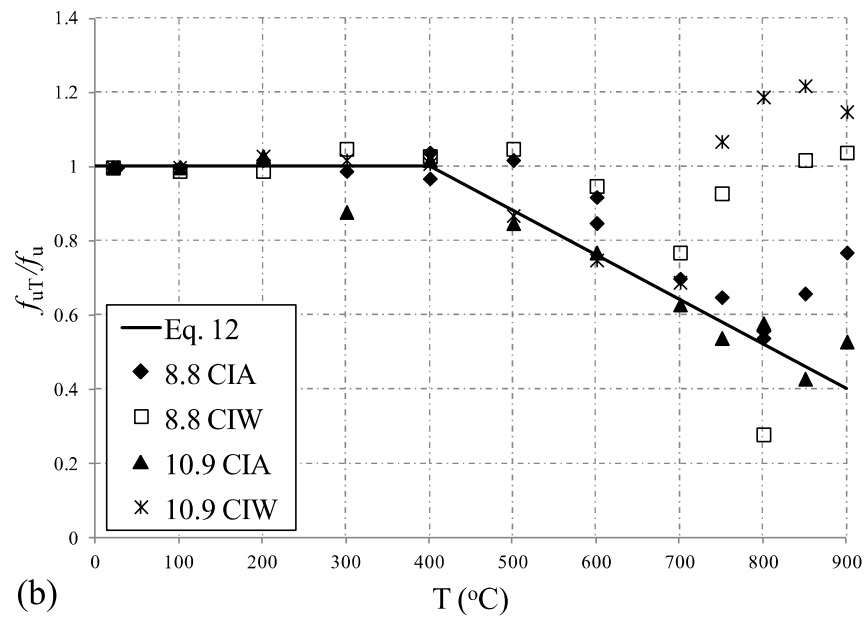
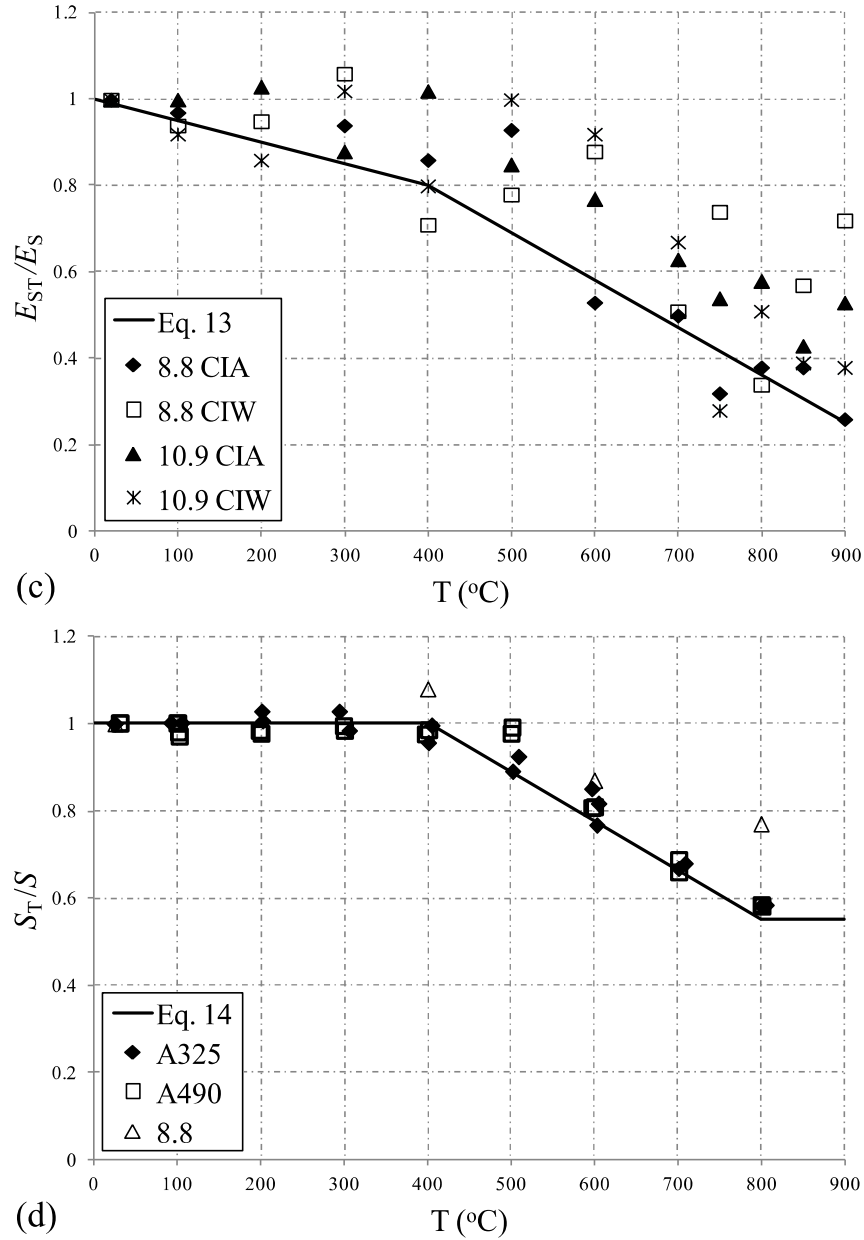
**Figure 8.** Comparison of predicted residual factors a)  $f_{yT}/f_y$ , b)  $f_{uT}/f_u$ , c)  $E_{sT}/E_s$  and d)  $S_T/S$  for high-strength bolts.

The residual factors of a) the yield strength,  $f_{yT}/f_y$ , b) the ultimate strength,  $f_{uT}/f_u$ , c) the elastic modulus,  $E_{sT}/E_s$ , and d) the shear strength,  $S_T/S$ , can be obtained from **Fig. 8**. Different bolt qualities (eg. class 8.8 and 10.9) demonstrate similar behavior after the fire event while the mechanical properties' enhancement for the water cooled specimens is easily noticed. The adopted formulas account for the air cooling experimental results, thus the worst case scenario. The proposed Eqs. (11)-(14), which are graphically compared with the test data in **Fig. 8**, indicate that the post-fire

properties remain unaffected for temperatures up to 400°C, whereas the mechanical properties deteriorate from 25-55% of the initial ones for temperatures up to 900°C.

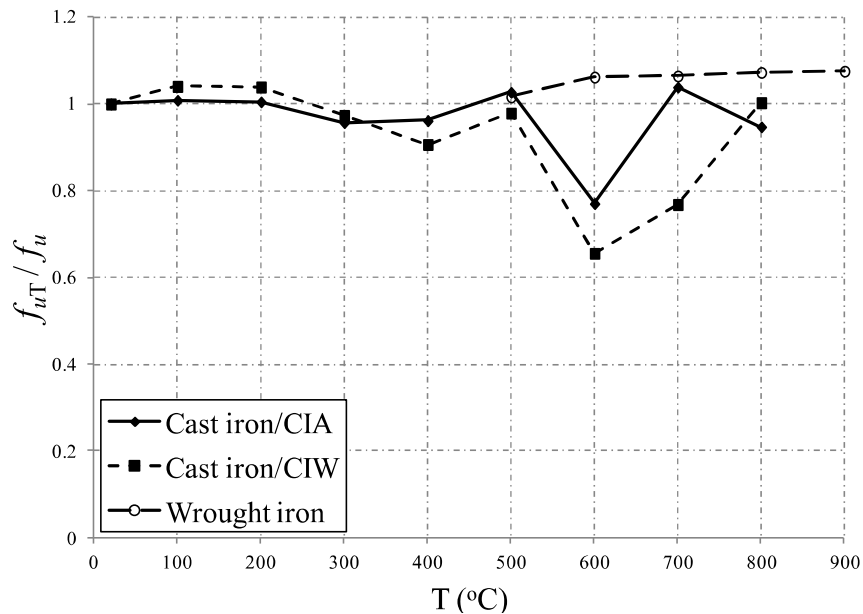
**Figure 9.** Residual factors  $f_{uT}/f_u$  for a) cast iron [14] and b) wrought iron [4].

Wrought and cast iron materials have been widely used in historical structures [14], the preservation of which should be taken into account after fire events. Their post-fire behavior was observed by Kirby et al. [4]. Nevertheless no experimental data is available nowadays, except the recent results conducted by Maraveas et al. [14]. The work conducted in this paper demonstrates the mechanical behavior of cast iron under high temperatures as well as after cooling to ambient temperature. The results indicate deterioration in capacity only for temperatures between 600°C and 700°C. Oppositely, wrought iron demonstrates the same mechanical behavior after cooling from elevated temperatures [4]. The observations above are graphically displayed in **Fig. 9**.
